IDR Sheet	1	of	1	Sheets	Final Record Book	Page
Contract			Day		Date	
C-7852			Wednesday		August 10, 2011

Inspector's Daily Report

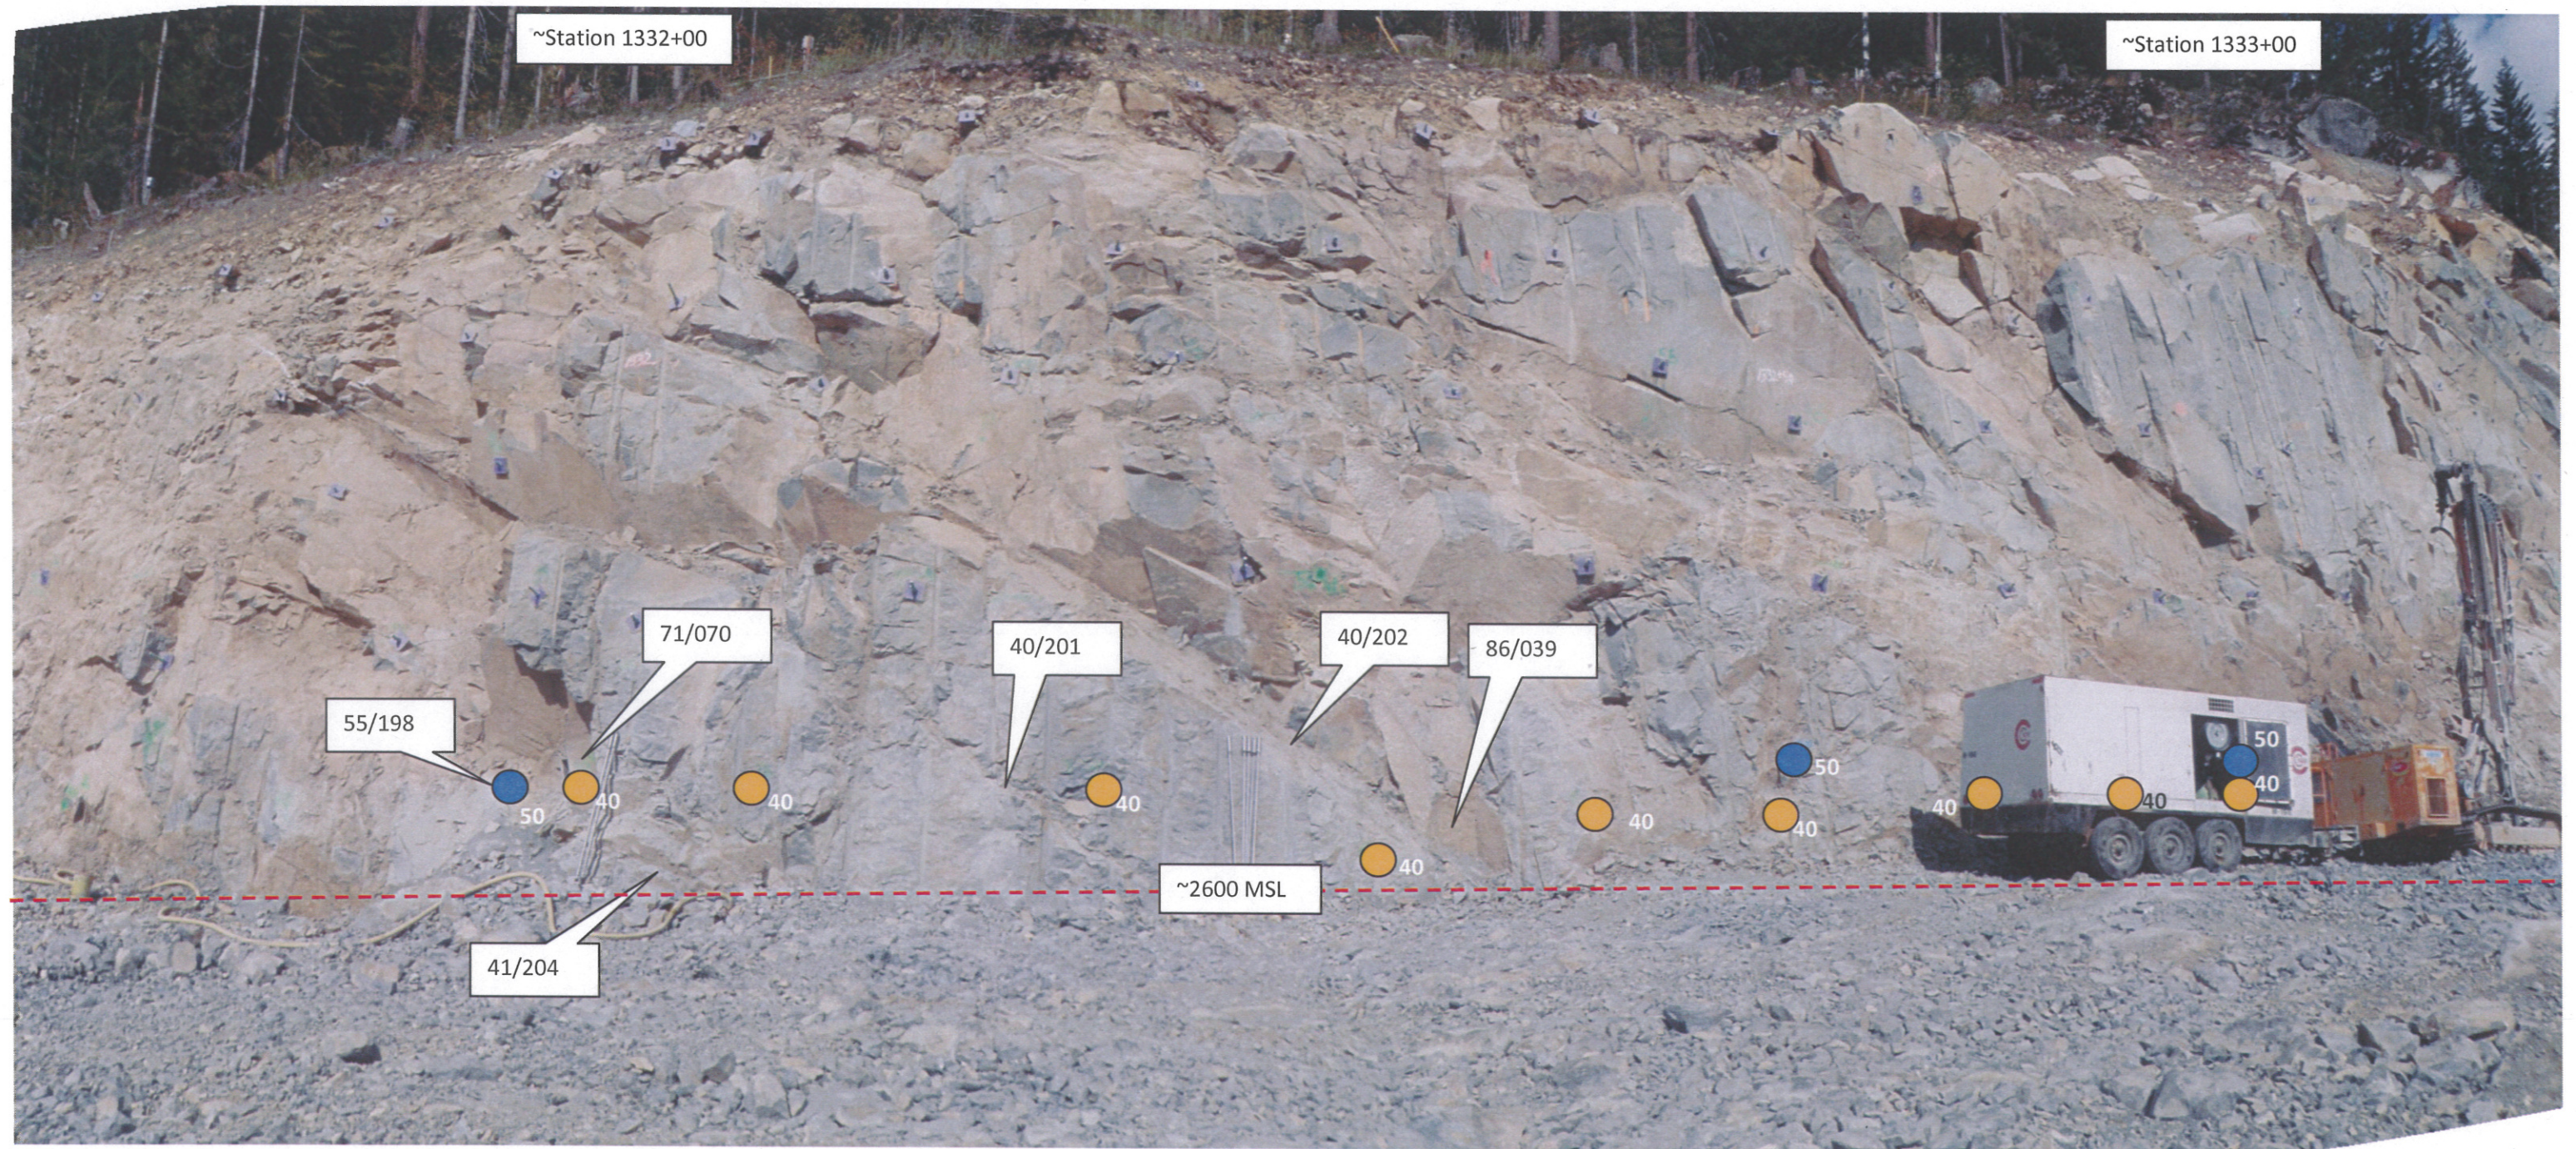
I met Brad Schut on the east end of the project around 7:00 am. Brad and Erik Warren were relocating the pattern H dowels underneath the soil nail wall that Eric Smith had located last week. Brad indicated that we could perform a lift inspection at Jenkin's Knob. We layed out nine 40-foot pattern H dowels and three horizontal drains from approximate station 1332+00 to 1333+00 to approximate elevation 2600 MSL (Figure 1). I also performed some additional mapping that is also shown on Figure 1.

Figure 1. A photograph showing the lift inspection from approximate station 1332+00 to 1333+00 to about 2600 MSL. Note that three dowels and one drain are located behind the drilling equipment in the photograph.
